**PRELIMINARY ASSESSMENT/  
VISUAL SITE INSPECTION**

**ENVIREX INC.  
(FORMER REXNORD - CORPORATE MANUFACTURING)  
MADISON, INDIANA 47250  
IND 006 374 722**

**FINAL REPORT**

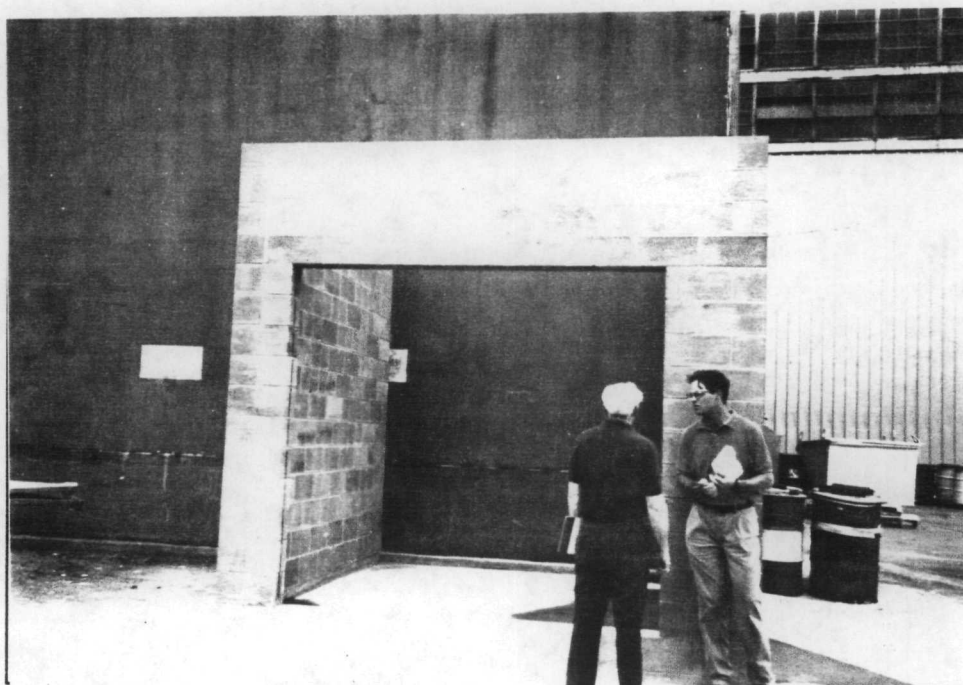
Photograph No. 6

**Observations:** During the inspection, the steam distillation unit was decommissioned. Envirex has constructed a small concrete block building to house this unit (see Photograph No 6). This unit measures approximately 8 feet by 8 feet, and has secondary containment. PRC observed no evidence of releases.

This unit does not pose a potential threat of release to the environment. This unit is currently inactive, and will be reactivated in August 1992. This unit was previously located in an open area. Envirex has constructed a concrete block building to house this unit. No spills or releases were observed or have been documented for this unit. The potential for release from this unit to the ground water, surface water, air, and on-site soils is low.

PRC recommends no further action at this time.

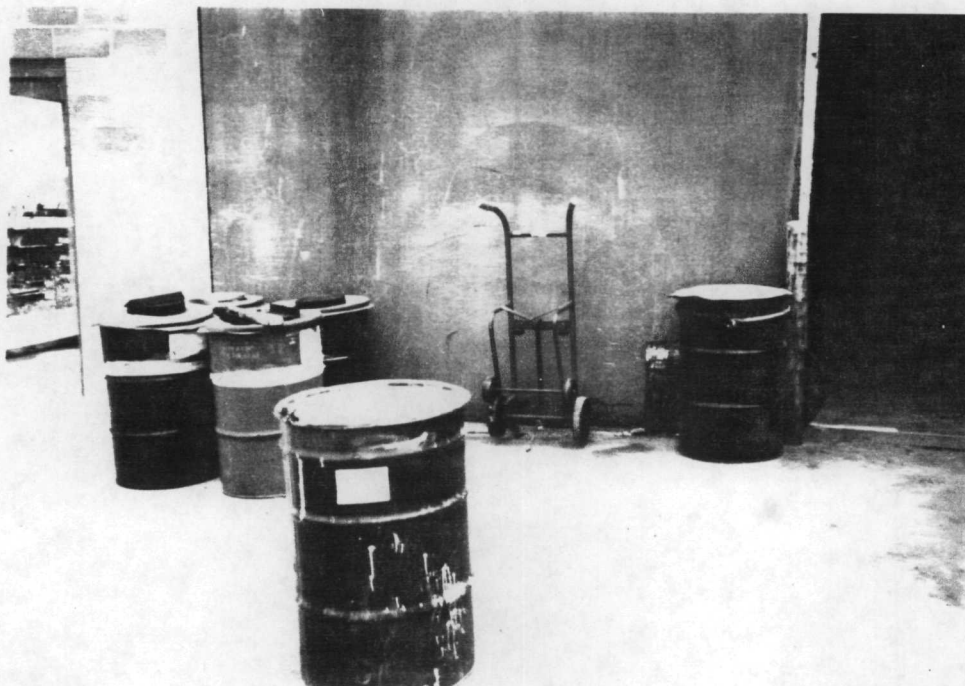
Photograph No. 7

**Observations:** During the inspection, PRC observed four, 55-gallon drums of spent filter wastes (F003, F005, and D001) stored in this unit. Furthermore, several empty drums were noted during the inspection. PRC observed no evidence of releases from this unit (see Photographs No. 7 and 8).

This unit does not pose a significant threat of release to the environment. Residual wastes are contained in 55-gallon drums that are sealed and stored on a concrete surface in an open area. No spills or releases were observed or have been documented for this unit. This unit does not contain any secondary containment. The potential for release from this unit to on-site soils is low to moderate, and to ground water, surface water, and air is low.

Description: This photograph shows reclaimed toluene and hazardous waste storage area.

PRC recommends that the facility install secondary containment for this unit to prevent potential release to the on-site soils.
